HIGHLANDER

Emergency Tank Repair Engineering

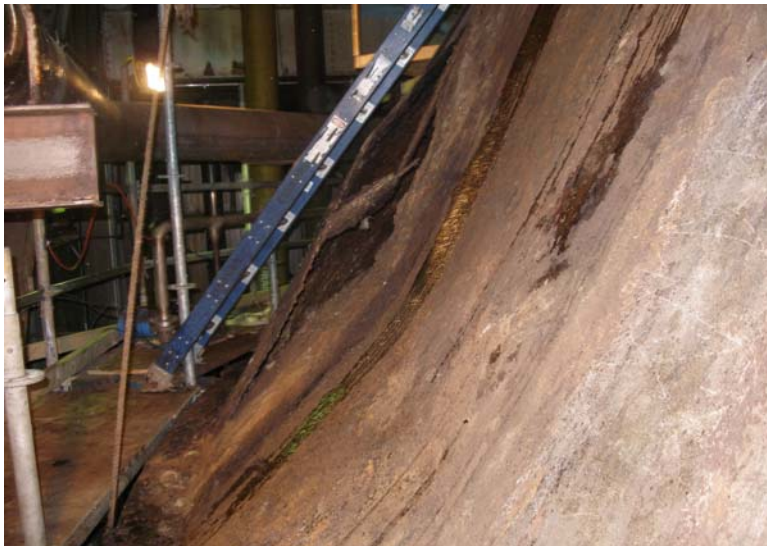
Cone Failed from Buckling, Cracking, & Corrosion

Atmospheric storage tank with equipment on top weighing approximately 500 tons failed in the transition cone between 21' diameter section and 40' diameter section for approximately 60 degrees of the circumference.

Temporary repair was designed which permitted lower tank to remain in operation and stabilize the upper section until replacement section could be installed during the next major outage.
